2016 Annual Site Inspection and Monitoring Report for Uranium Mill Tailings Radiation Control Act Title II Disposal Sites

November 2016

**U.S. Department of Energy
Office of Legacy Management**

**2016 Annual Site Inspection and Monitoring Report
for
Uranium Mill Tailings Radiation Control Act
Title II Disposal Sites**

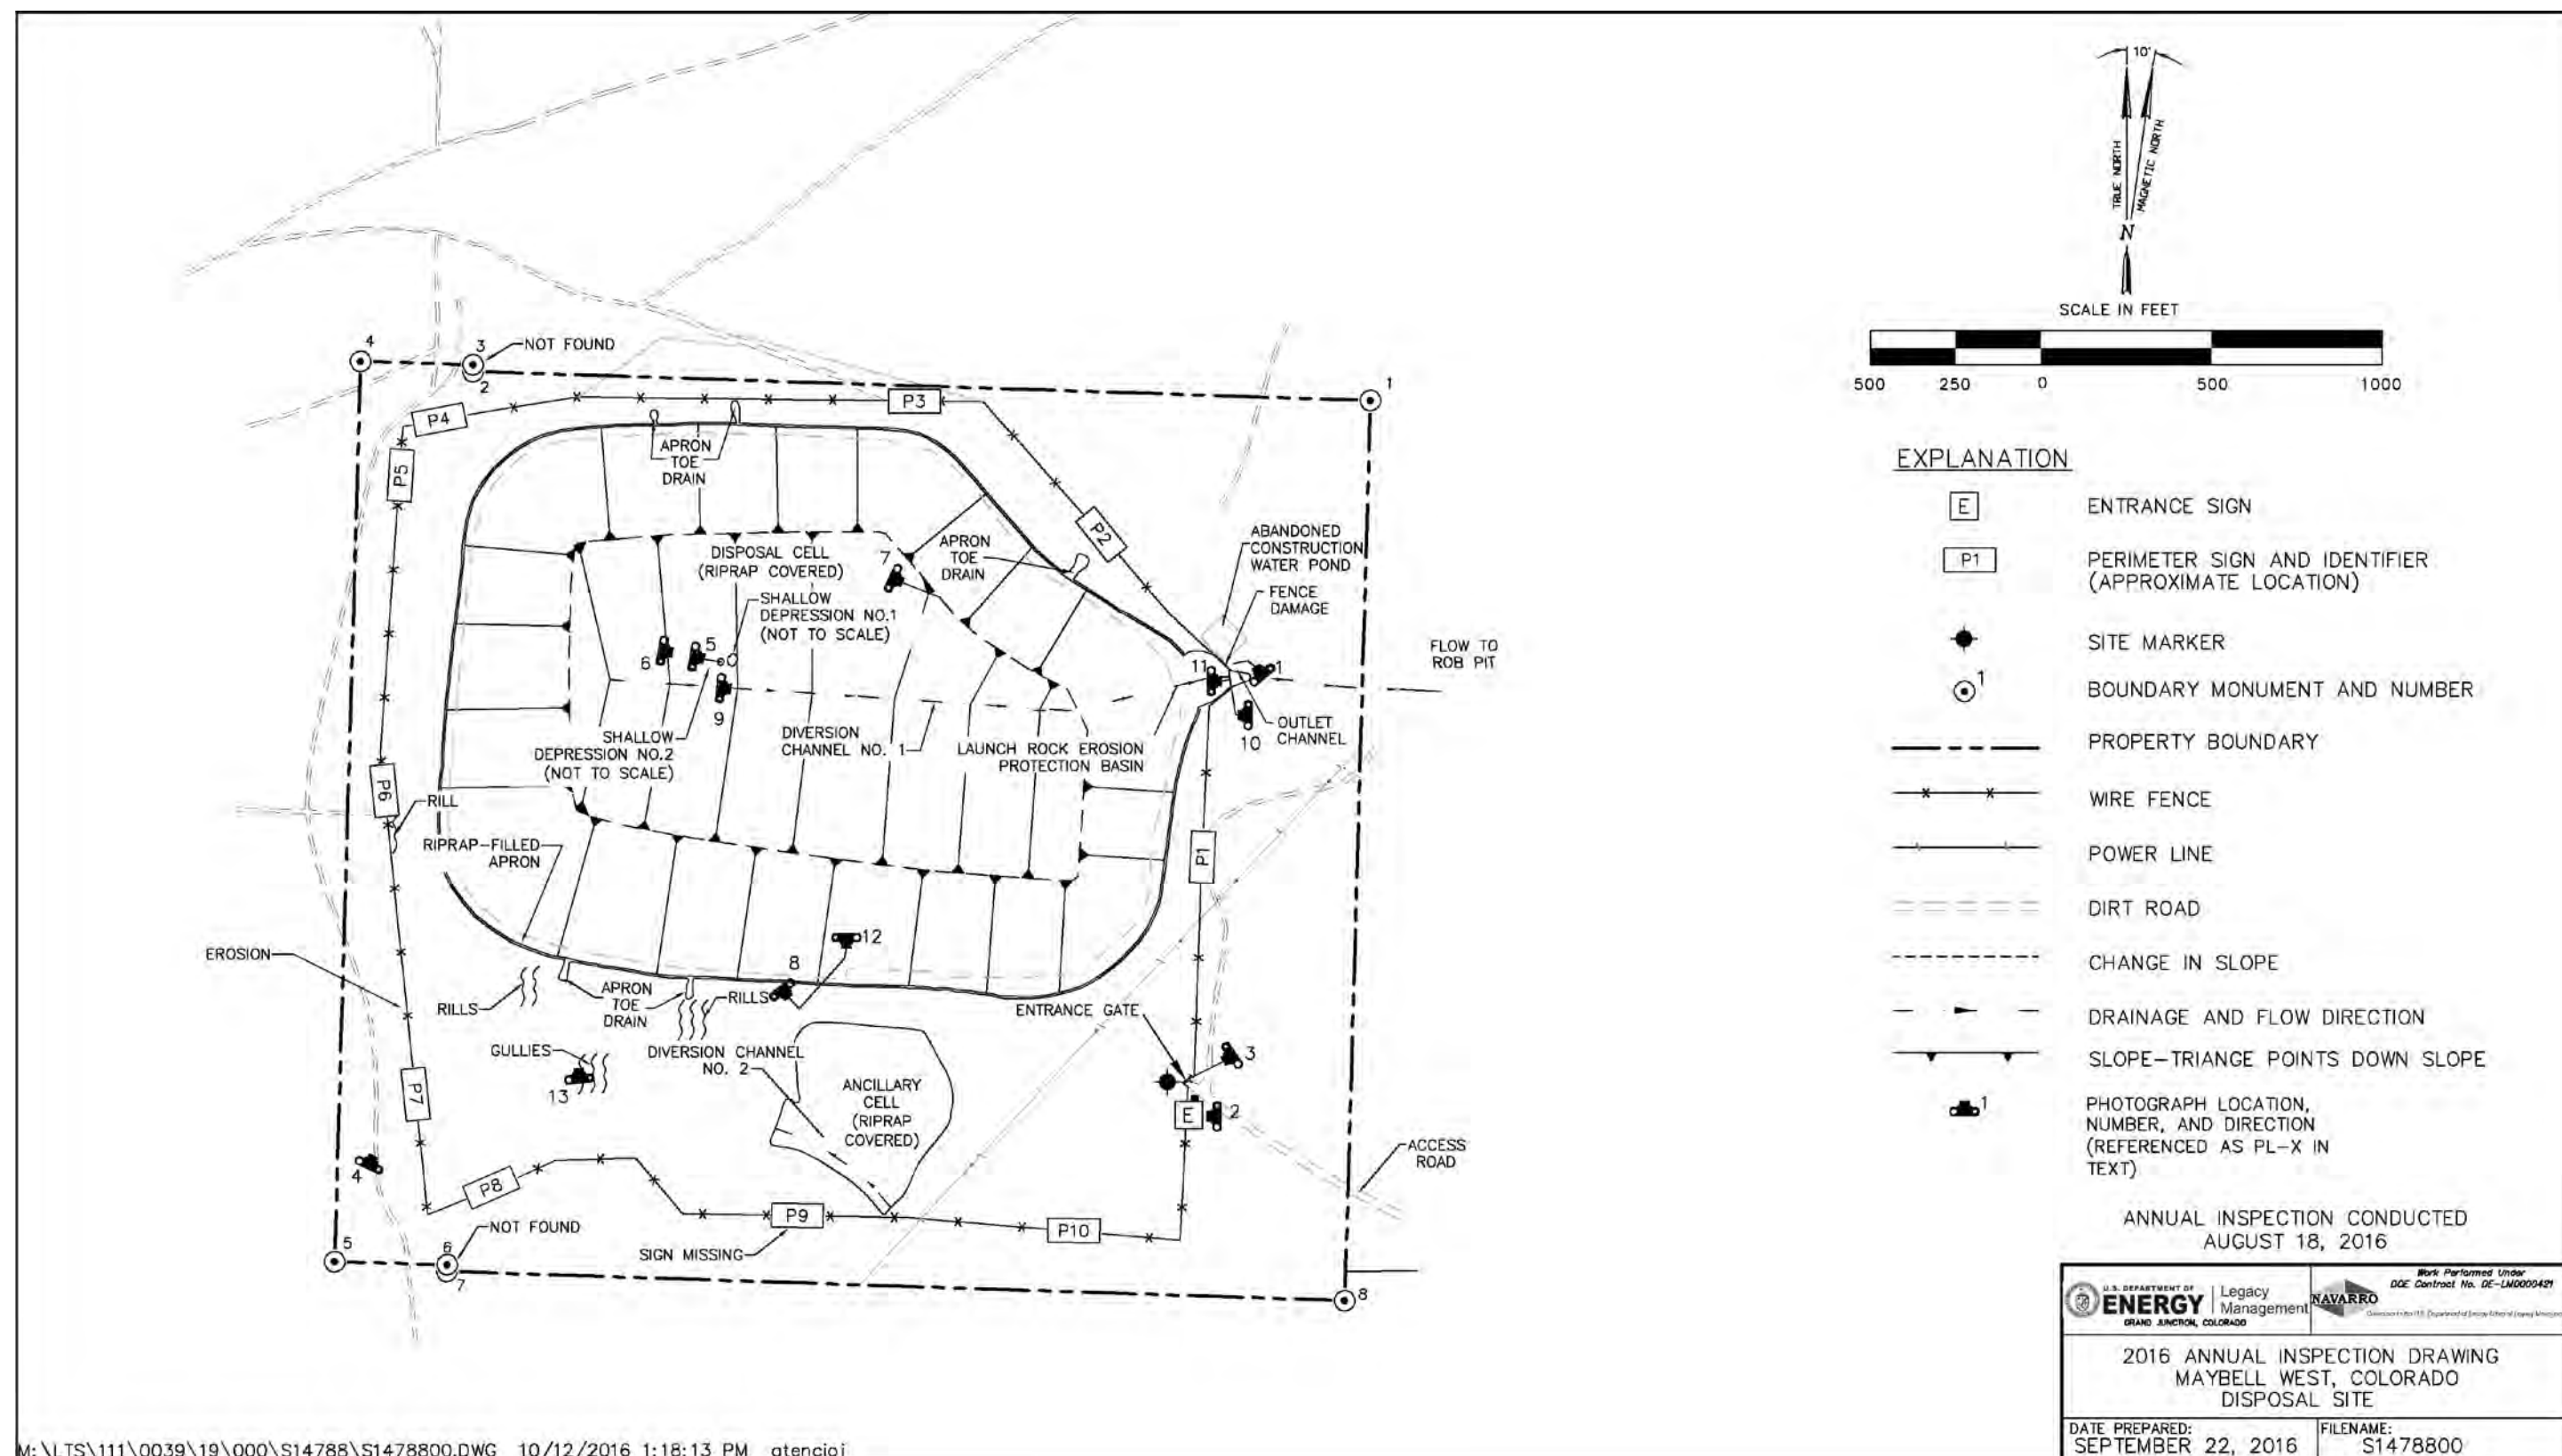
Figure 4-1. 2016 Annual Inspection Drawing for the Maybell West, Colorado, Disposal Site

A standard four-strand barbed-wire stock fence surrounds the disposal cell, the ancillary cell, the drainage structures, and much of the site. The fence facilitates land management by DOE, because the site is in wintering grounds frequented by big game animals (primarily pronghorn, deer, and elk) and is also surrounded by open range land used for cattle grazing. With the exceptions of a damaged fence post and the associated loose fence strands (PL-1) and erosion occurring along a short portion of the fence line, no maintenance needs were identified. Those fence repairs will be made when more significant repairs are needed; the fence remained functional. The entrance sign is mounted on a perimeter fence metal t-post directly south of the entrance gate (PL-2). The entrance sign remains legible. Ten warning or perimeter signs are mounted on perimeter fence metal t-posts around the site. Perimeter sign 9 was missing and will be replaced. The remaining perimeter signs remain legible.

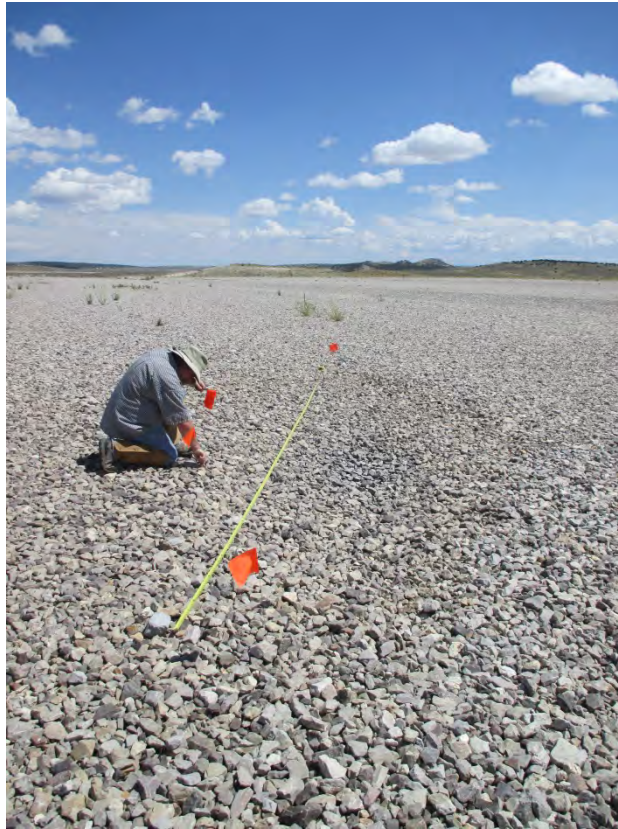
PL-5. Measuring Depression No. 1

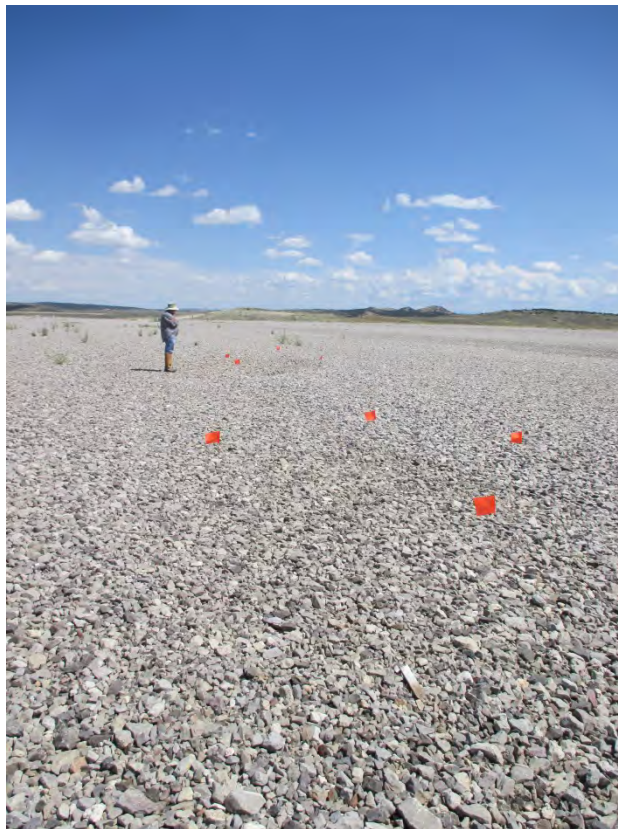
PL-6. Depression No. 1 and No. 2 Marked by Pin Flags

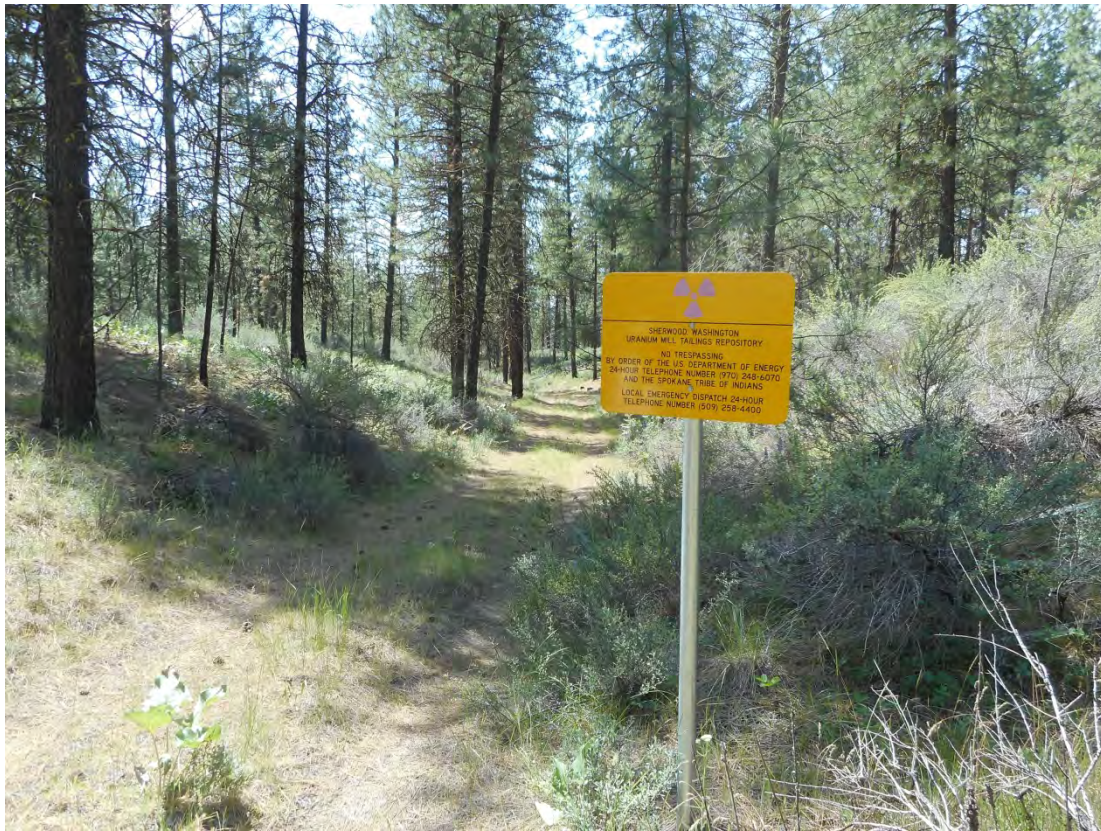
Six warning or perimeter signs, designated P1 through P6, are along the site boundary at likely access points around the site. The signs are attached to steel posts set in concrete. Vandalism of signs commonly occurs, including removal of signs or bullet damage. Text on signs may become illegible due to fading or bullet damage. Missing or illegible signs are replaced as necessary. All of the signs were present and legible, and no maintenance needs were identified (PL-1).

PL-1. Perimeter Sign P4

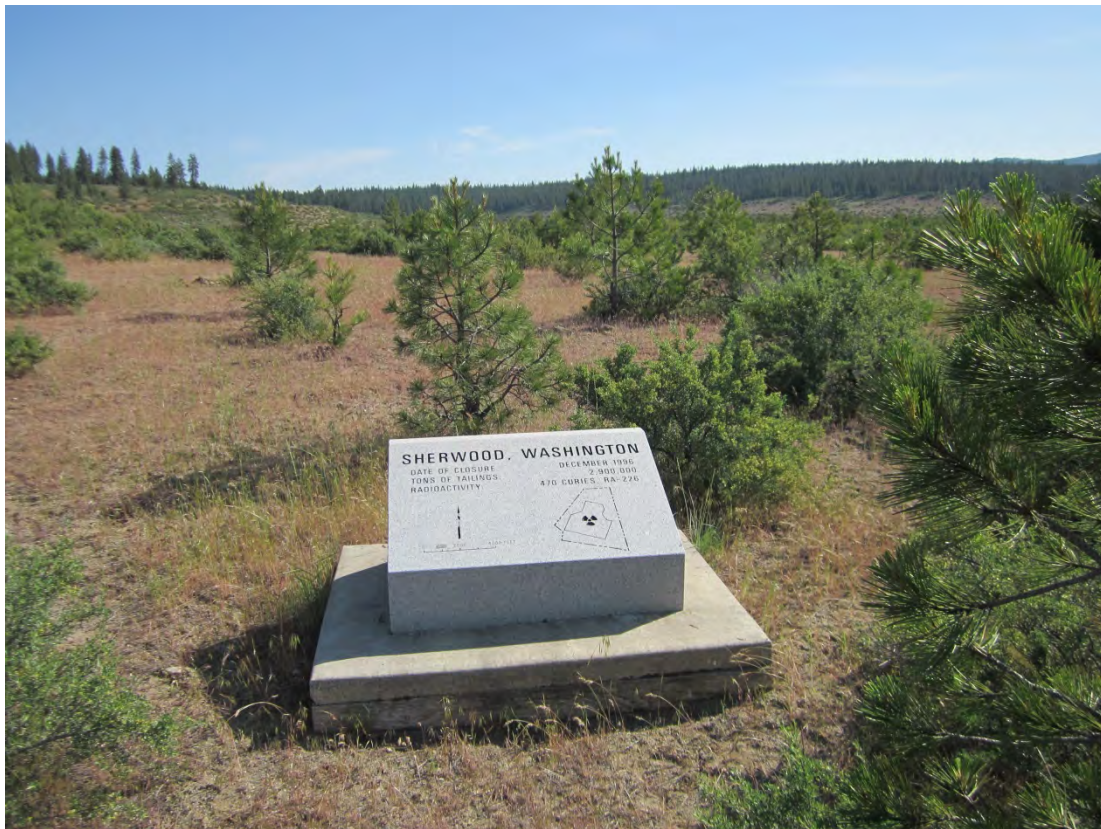
One granite site marker is present on the southwest side of the site where the access road lies closest to the site boundary. Site marker was stable and legible. No maintenance needs were identified (PL-2).

PL-2. Granite Site Marker

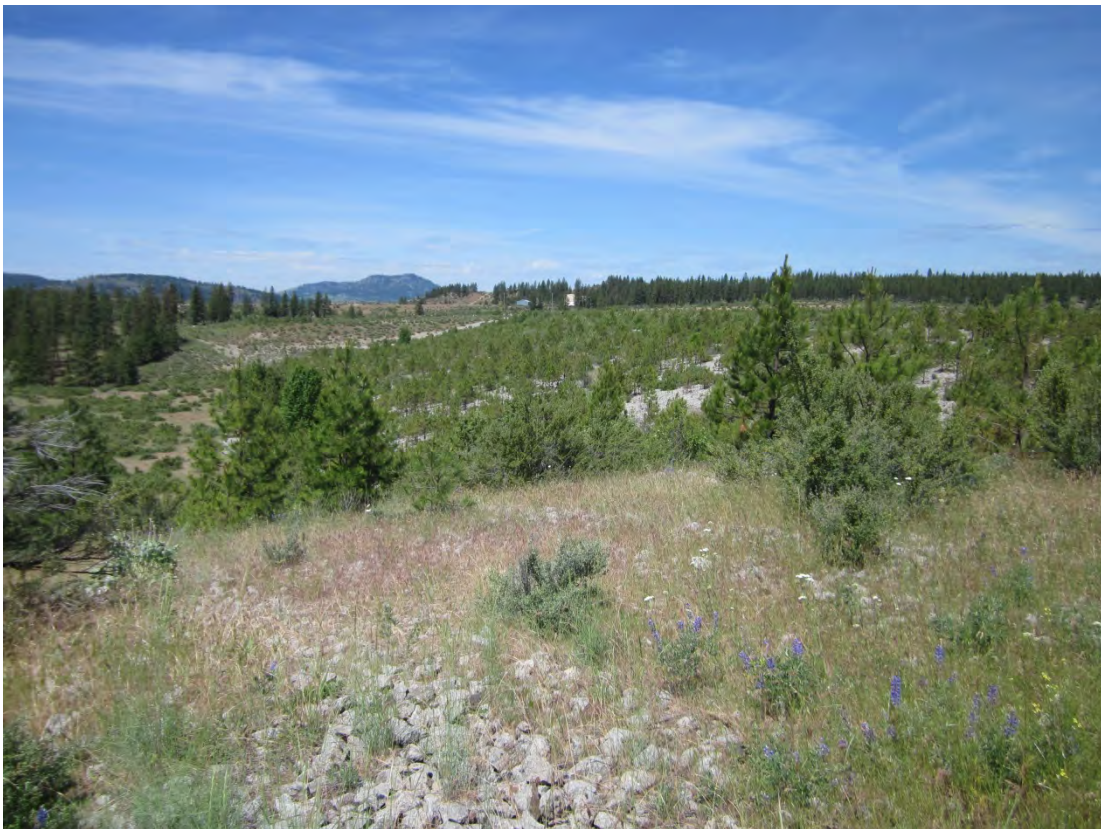
The tailings dam face has a rock cover consisting primarily of highly durable quartz monzonite. The face was designed to allow a vegetated cover, including mature trees, to establish and stabilize the surface and prevent erosion. Consequently, the presence of this vegetation does not harm the function of the dam, and the dam will not be compromised if the rock cover eventually degrades. The dam face is thickly vegetated (PL-6).

PL-6. Face of Tailings Dam, View to West

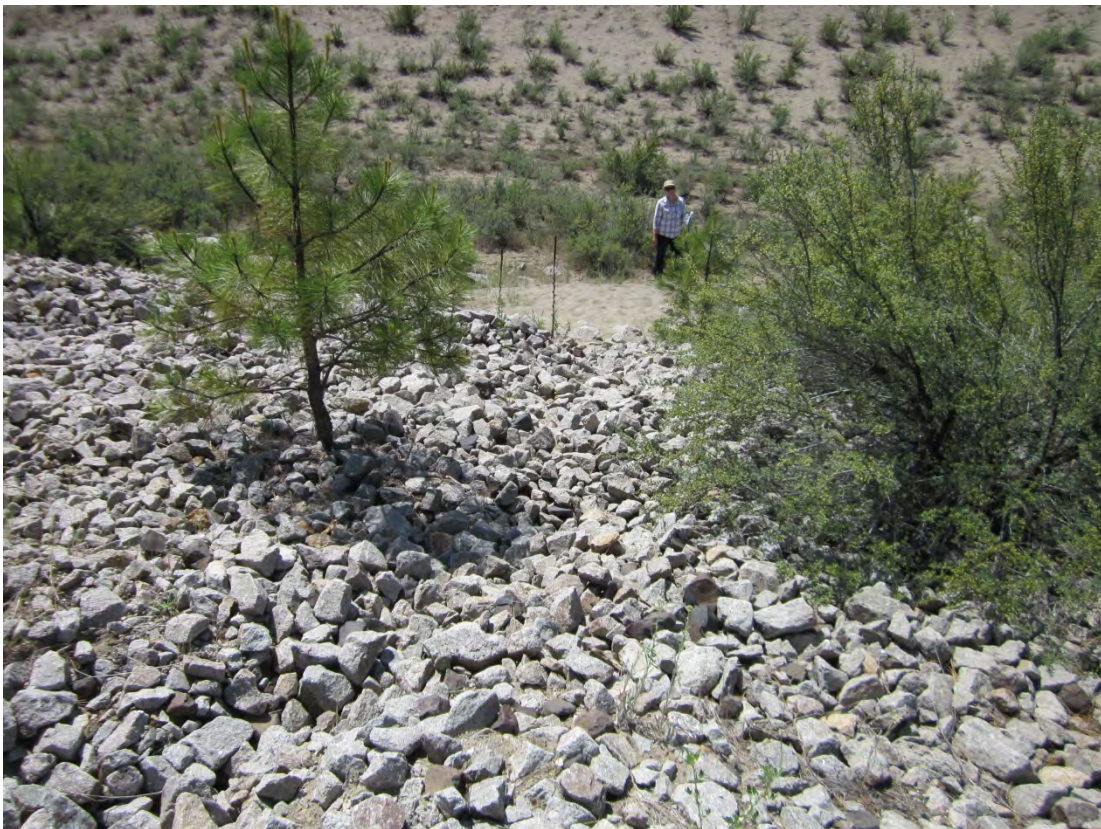
During the 2016 annual inspection, one area at the base of the rock-covered dam face was found to have a fan of sand that had washed out from underneath the rock cover (PL-7, PL-8). A small rill could be traced from the dam base up approximately 50 feet under the cover. The rill ranged from 1 to 2 feet wide and 8 to 12 inches deep. A return visit to the site was performed on October 4 and 5 to evaluate the cause, extent, and repair of the erosion, if required. A report will be transmitted to the NRC upon completion of the engineering evaluation.

PL-8. Erosion at Base of Dam, View to Southwest

If yes discuss in report: *Sand is washing out from under the rock armored face of the cell at one location (see photos PL-7 and PL-8 in report). A small gully can be followed 50 feet back up the face and is from 8" to 12 deep, approximately 1 1/2 to 2 feet wide. The closest tailings are some 800 feet away in the cell. A second trip to the site will be made to determine the cause, extent, and possible remedy.*

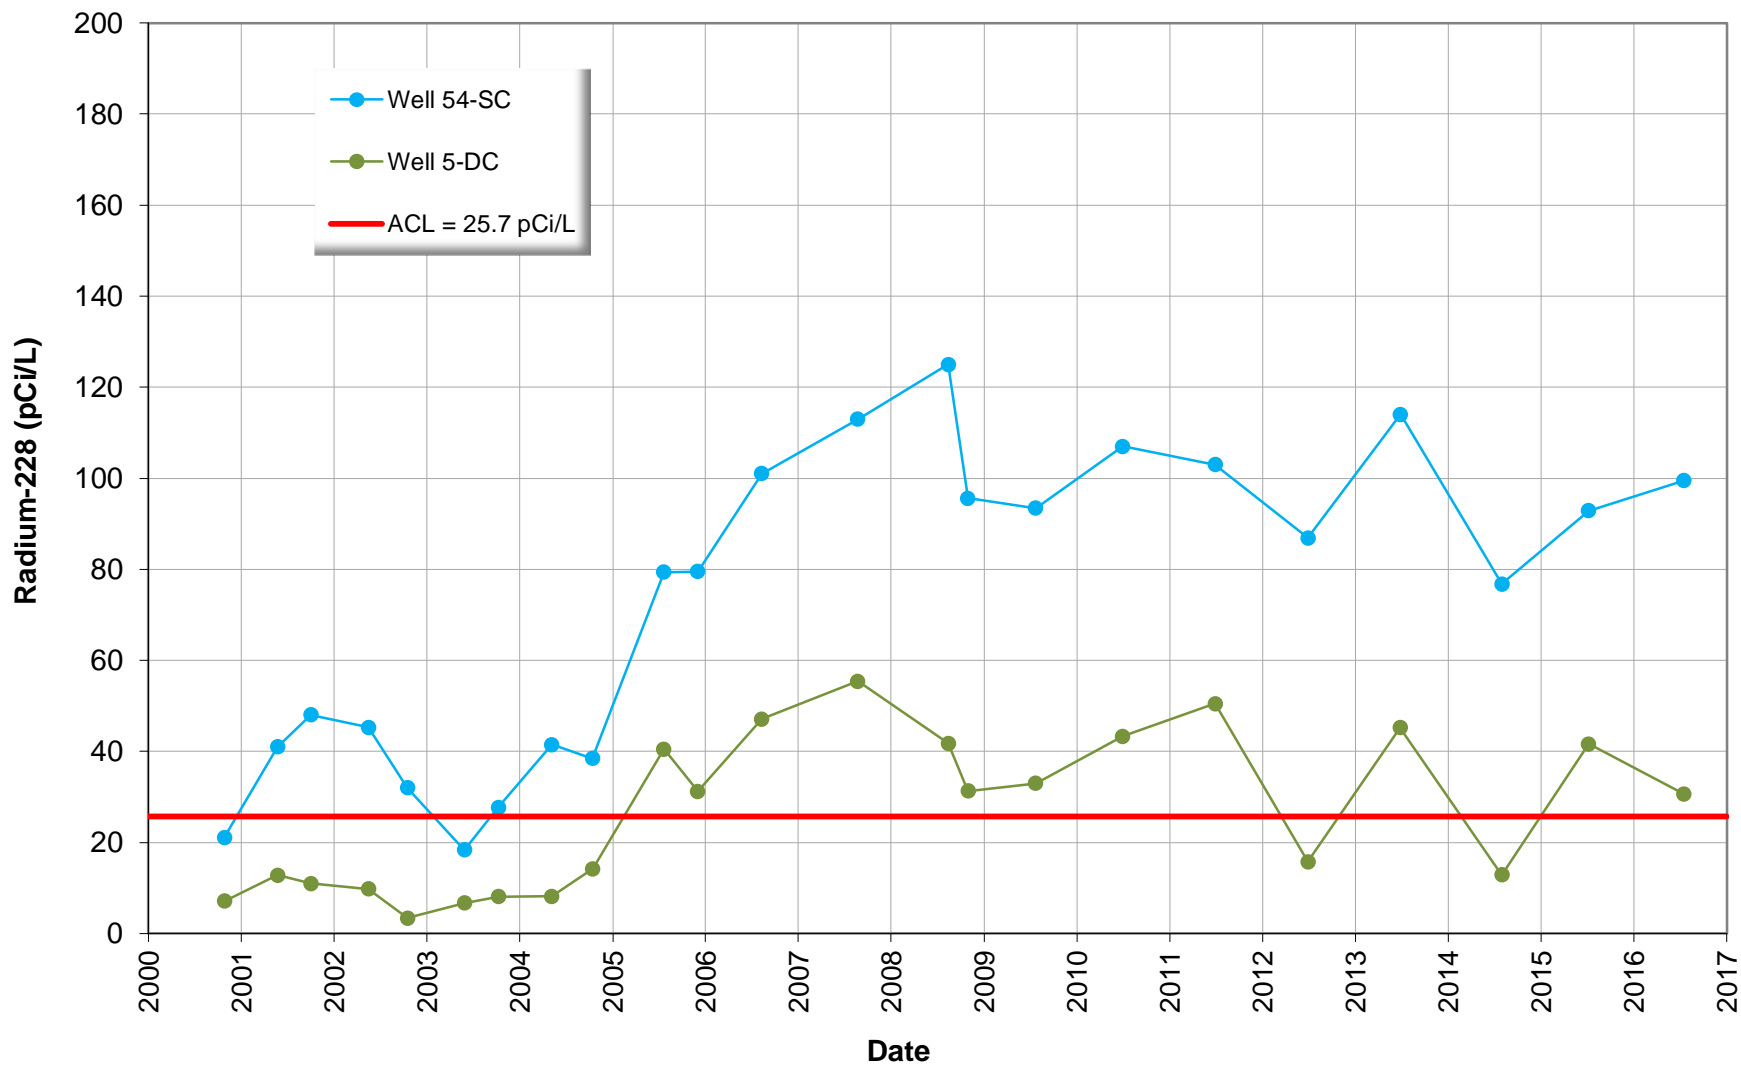
The concentration of cadmium in well 5-SC remained less than the ACL as it has since 2005. Radium-228 continued to exceed the ACL in both wells 54-SC and well 5-DC (Figure 6-2). Additionally, the ACL for radium-226 continues to be exceeded in well 110-DC (Figure 6-3).

Figure 6-2. Radium-228 Concentrations in Wells 5-DC and 54-SC Since Completion of the Disposal Cell at the Shirley Basin South, Wyoming, Disposal Site

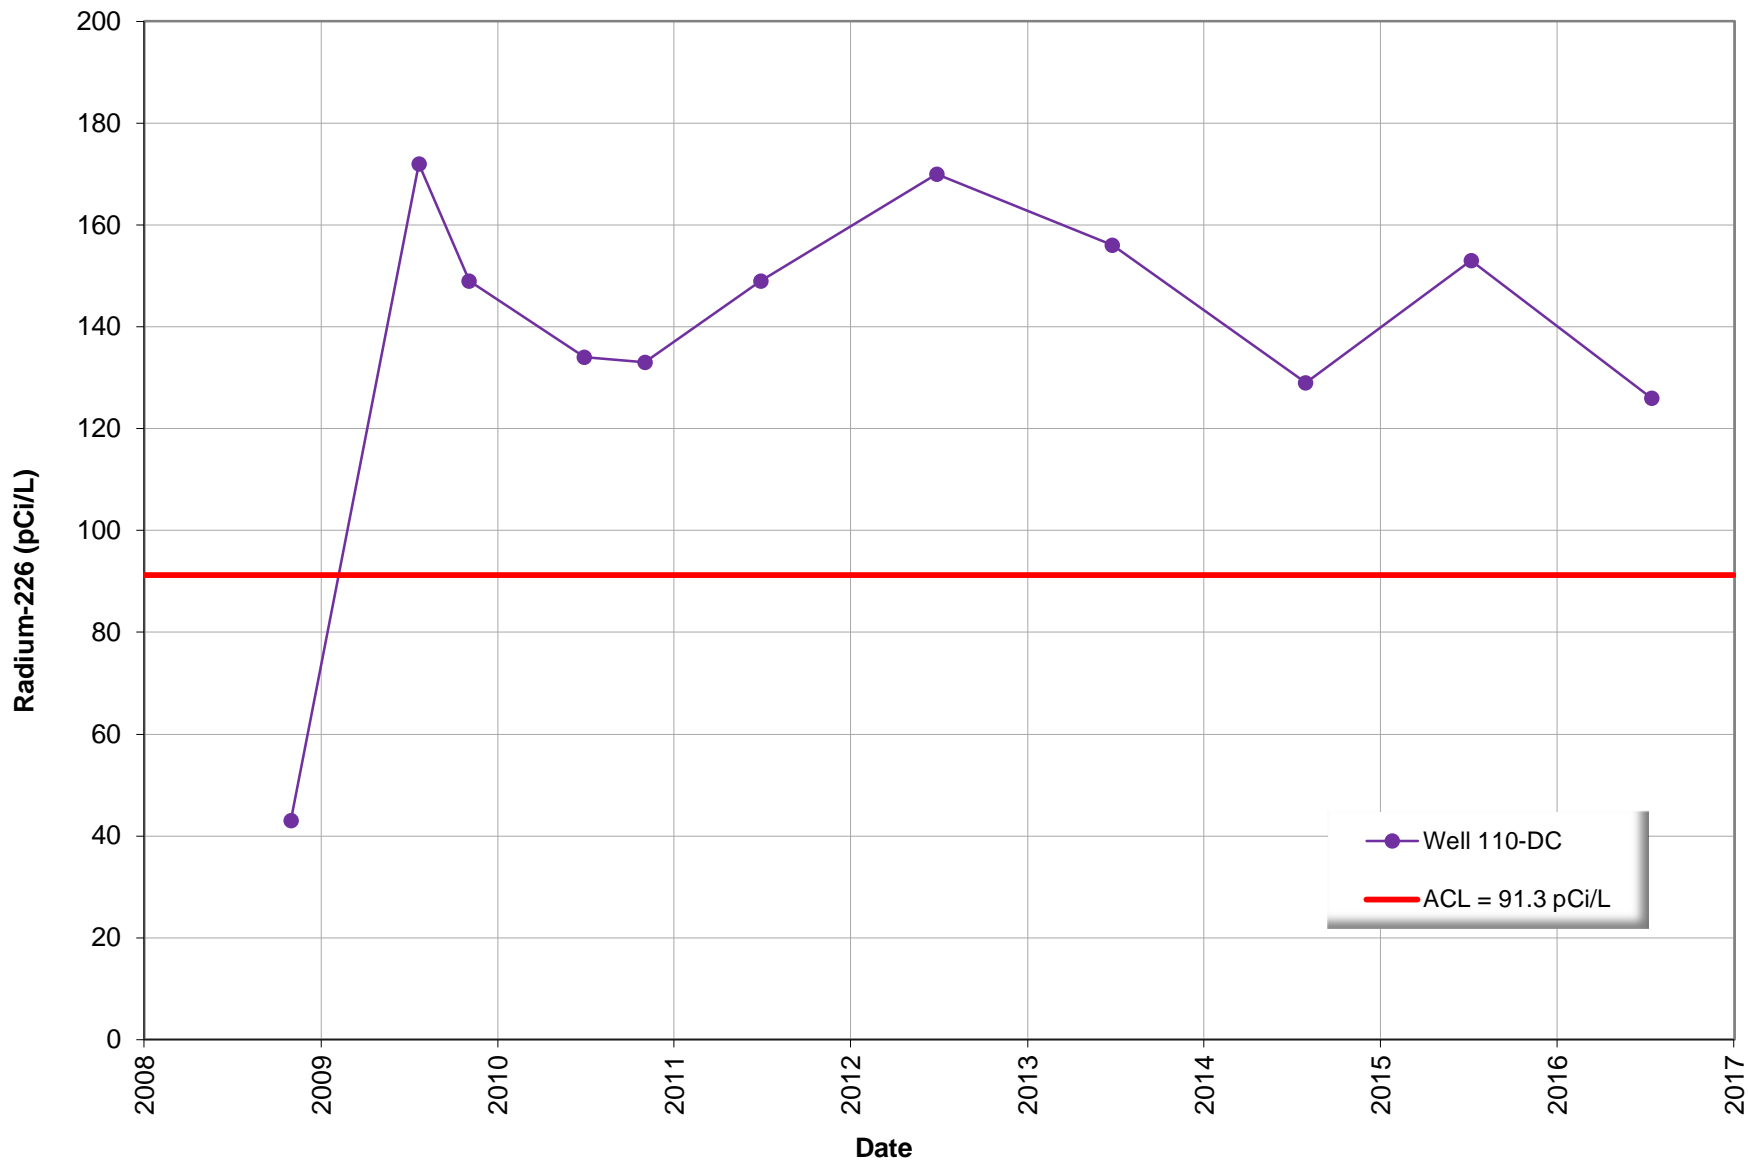
Wyoming Class III groundwater protection standards (applicable only to chloride, sulfate, and TDS) apply to water quality at the site boundary. The standards were met at the downgradient site boundary wells (100-SC, 102-SC, 110-DC, 112-DC, and 113-DC). The standards were exceeded for sulfate and TDS in wells 5-SC, 54-SC, and 5-DC; for radium-228 in wells 54-SC and 5-DC; and for radium-226 in well 110-DC. The 2016 results were within the range of historical measurements for these wells. The exceedances are found in wells near the disposal cell except for the radium-226 exceedance at well 110-DC. Well 110-DC is near a uranium ore deposit and the radium-226 concentration is around 17 times that of the upgradient POC well 5-DC. Therefore, the radium-226 in well 110-DC is probably naturally occurring.

Figure 6-3. Radium-226 Concentrations in Well 110-DC at the Shirley Basin South, Wyoming, Disposal Site

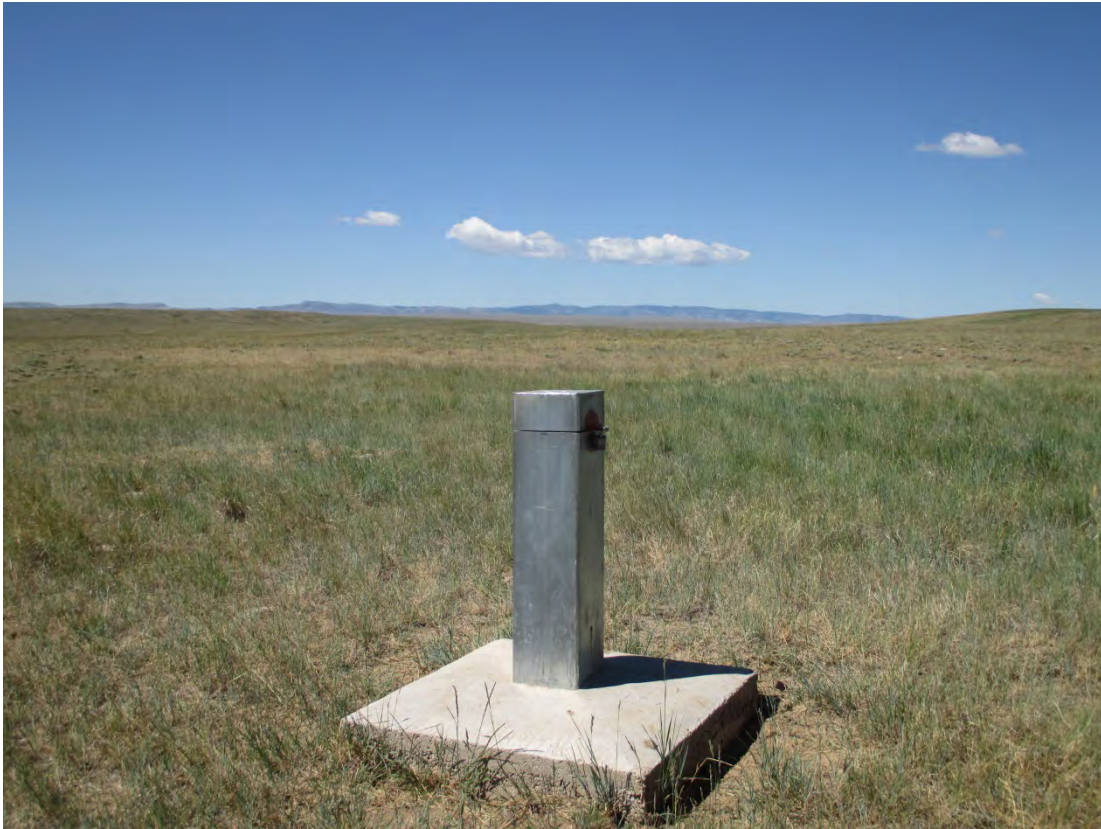
The site groundwater monitoring network consists of 14 wells; six of these wells were installed downgradient of the disposal cell in the fall of 2008. The wellhead protectors were undamaged and locked (PL-5). No maintenance needs were identified.

PL-5. Monitoring Well 113-DC

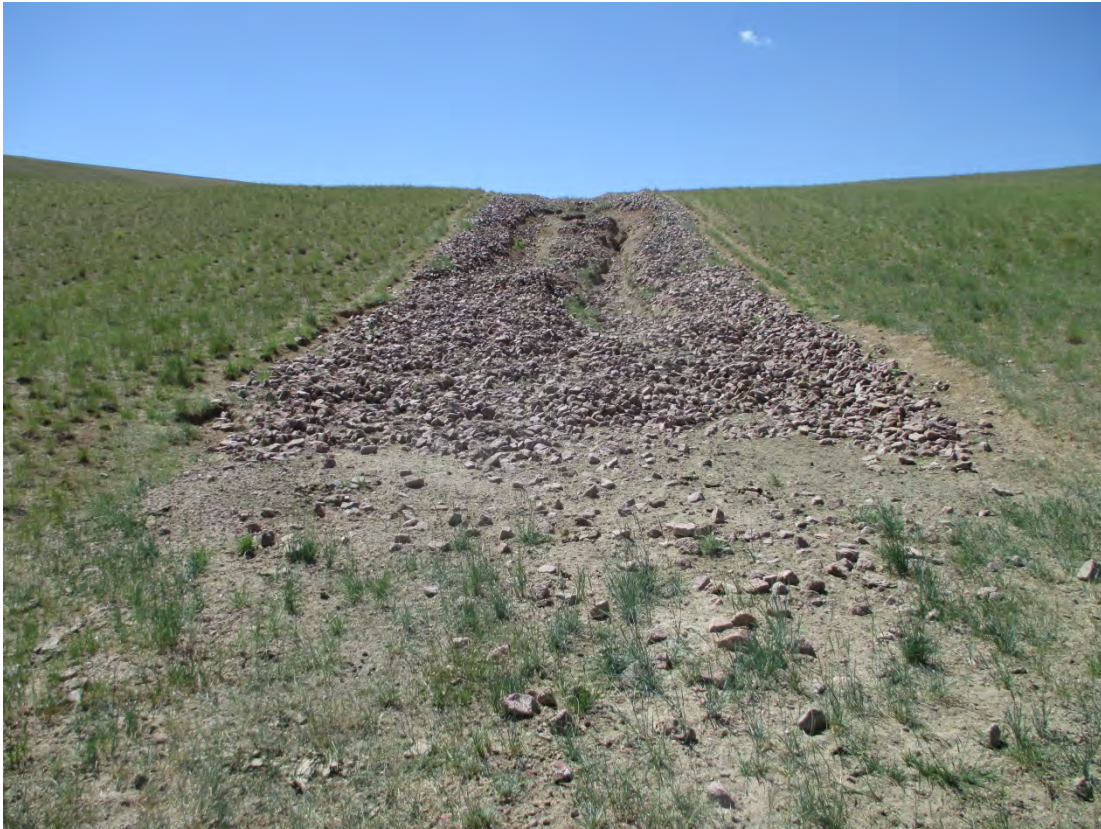
PL-13. Outlet of Eroded Riprap-Armored Drainage near Bottom of Pit 4
